# Partial Discharge on Outdoor Terminations

## Contamination of cable terminations causes PD

## The challenge

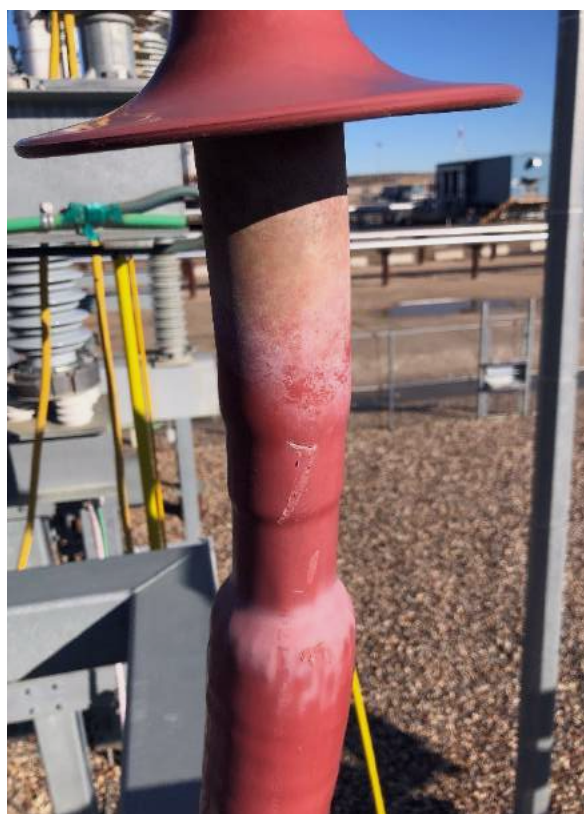
A high voltage asset owner in central Canada has numerous terminations on substation structures. Clearly salt contamination is not the issue. However other contamination is building up unevenly on their terminations.

*Cable termination H3 with uneven contamination*

Two of the terminations (H1 and H3) scanned returned very high levels of ultrasonic energy. The phase resolved plots show typical PD results. The source is frequency locked to the power system and the impulses are occurring twice a cycle, half a cycle apart.

During the next scheduled outage, the insulators were cleaned and then rescanned. The ultrasonic energy was gone, proving that the discharge was a result of the contamination.

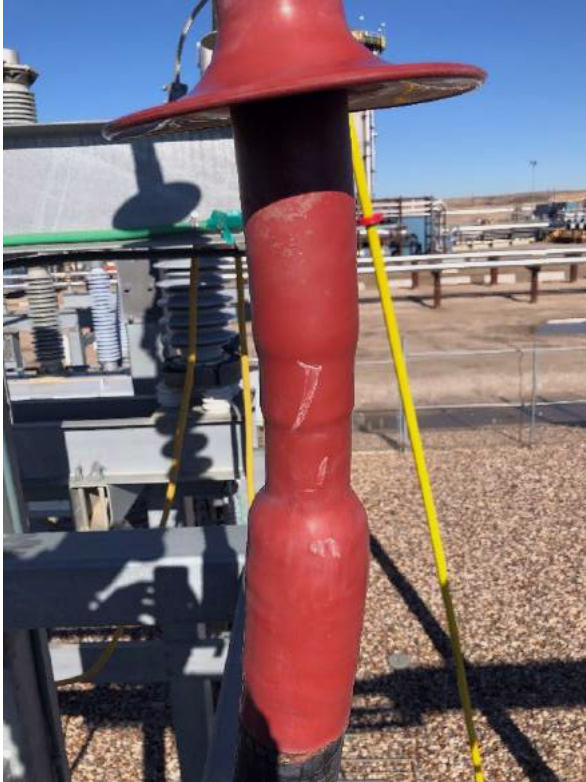
Cable termination H3 after cleaning

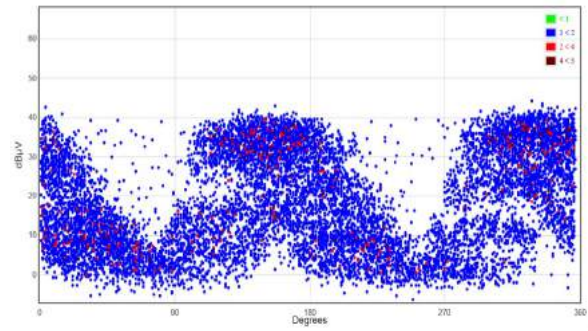
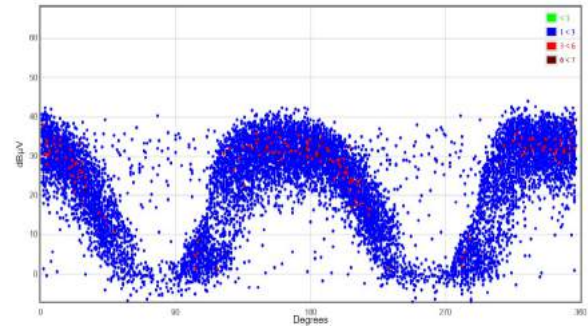
The levels are approaching 40dBuV which is very high. The ANSI/NETA MTS 2019 standard calls for immediate action on levels greater than 6 dBuV.

Ultrasonic PD results prior to cleaning

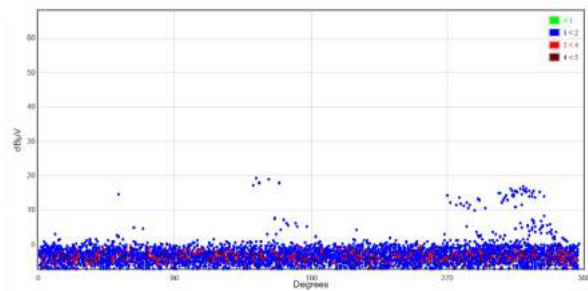
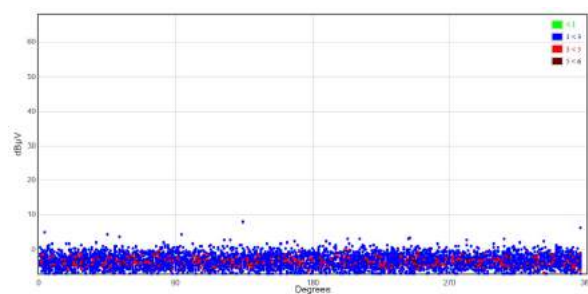
Ultrasonic PD results after cleaning
